# Manhole Inspection Summary

Manhole # S33C\_\_056MH

Insp Date: **8/27/08 8:37 AM**

**Location** Address: **240 w saratoga st**

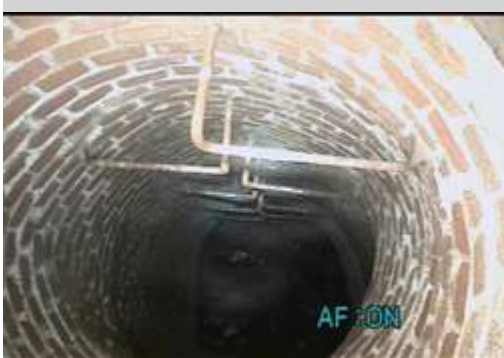
Defect 1

Count: **9** Missing: **0** ☒ **Corroded**

steps

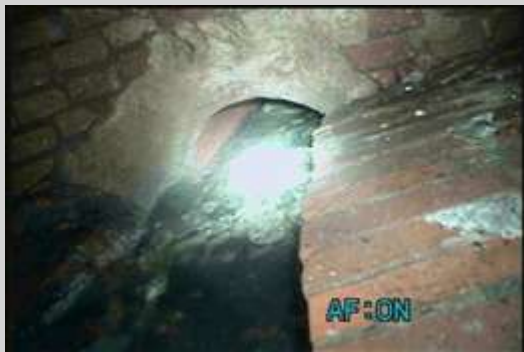
12 O'Clock Outflow

15 in. Circular Gravity Sewer  
Pipe Out @ 12 O'Clock

Invert Depth: **14.92** (ft.) Flow Characteristics: **Fast**

Deposits: ☒ None ☐ Mud ☐ Sludge ☐ Debris ☐ Grease

Infiltration: **None** Pipe Seal Cond: **Unknown**

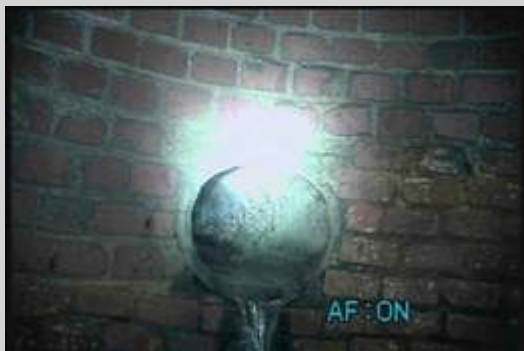
5 O'Clock Inflow

10 in. Circular Gravity Sewer  
Pipe In @ 5 O'Clock

Invert Depth: **14.50** (ft.) Flow Characteristics: **Fast**

Deposits: ☒ None ☐ Mud ☐ Sludge ☐ Debris ☐ Grease

Infiltration: **None** Pipe Seal Cond: **Unknown**

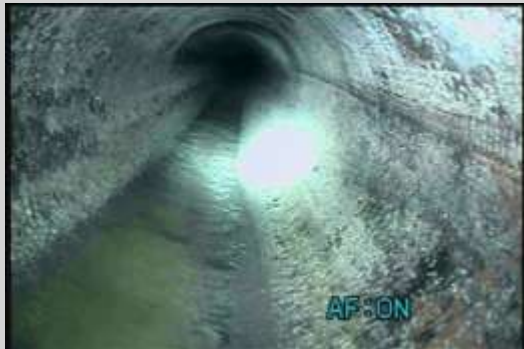
7 O'Clock Inflow

10 in. Circular Gravity Sewer

Pipe In @ 7 O'Clock

Invert Depth: **14.63** (ft.) Flow Characteristics: **Fast**

Deposits: ☒ None ☐ Mud ☐ Sludge ☐ Debris ☐ Grease

Infiltration: **None** Pipe Seal Cond: **Unknown**
